Summary of PS Module Irradiation

K. Einsweiler, LBNL

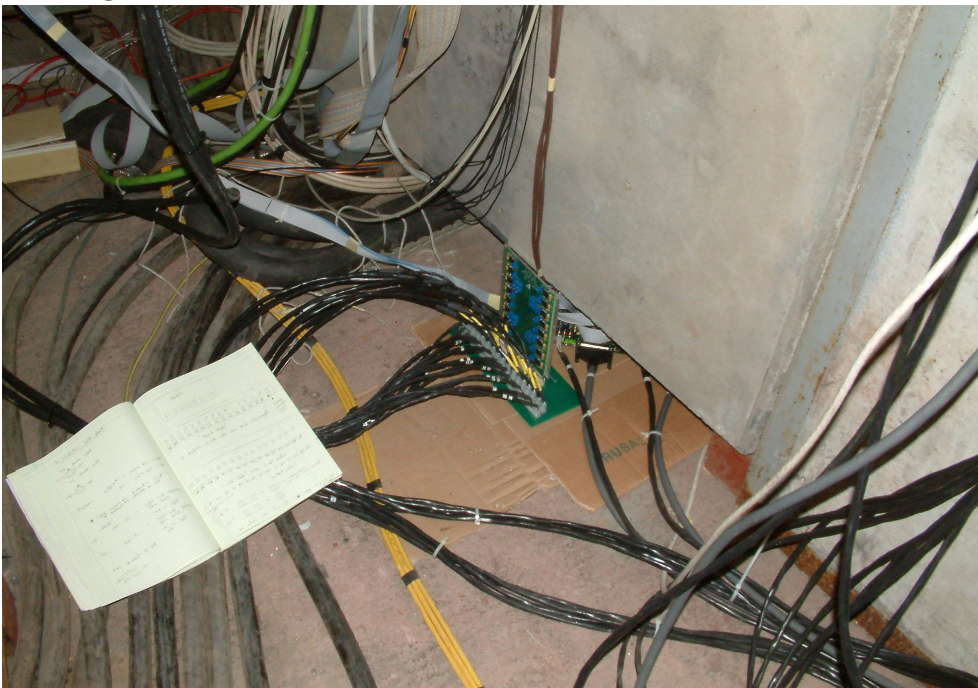
TPCC are largely hidden under concrete shielding blocks.

Regulator board is rad-hard, so it could be left out. This was required for cooling and for cable plant.

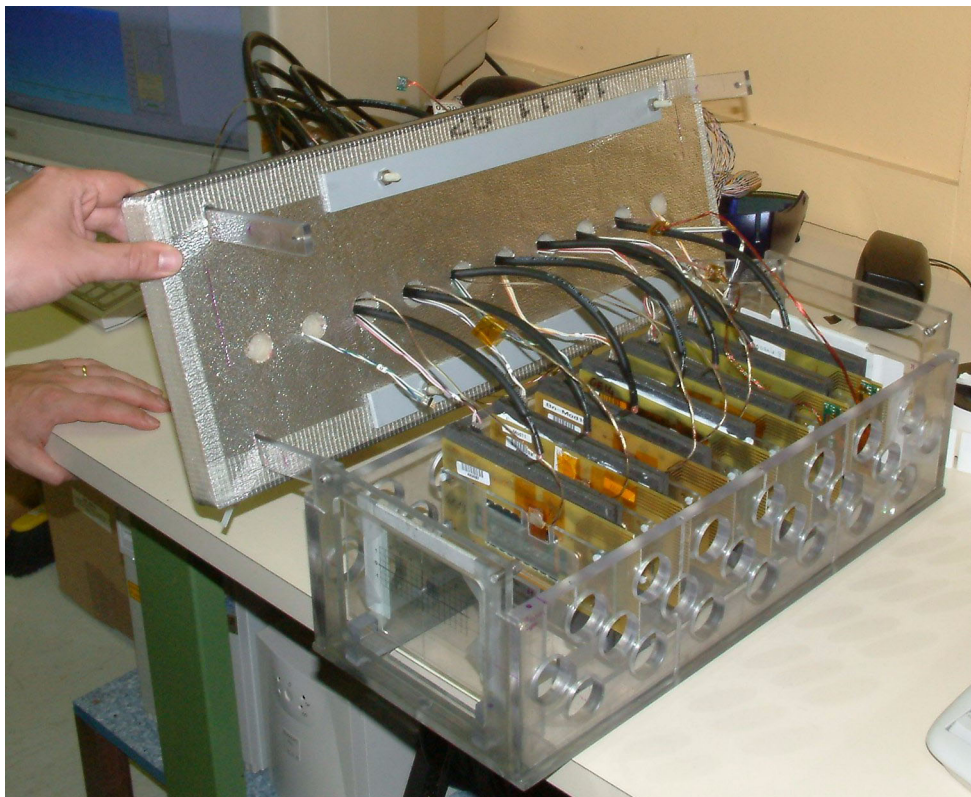
Cold box with modules:

Modules are located in plastic basket, which is suspended from top of box.

PP0 Support card on top of box is crosspoint for all of the electrical services.

Cooling valves are at lower right in beam.
